RE: Progress report for February 2007 activities - Hecla Mining Company Apex Site (EPA ID No. UT982589848, Docket No. RCRA-8-99-06)

SUBJECT: **Progress Report No. 34 for period ending February 28, 2007; Pond 2 Final Closure - Apex Site, Washington County, Utah**

TO: Paul Glader (Hecla Mining Company)
FROM: Doug Gibbs (Monster Engineering Inc.)
DATE: 2/20/07
SUBJECT: Surface Monument Survey Data Review – Apex Site

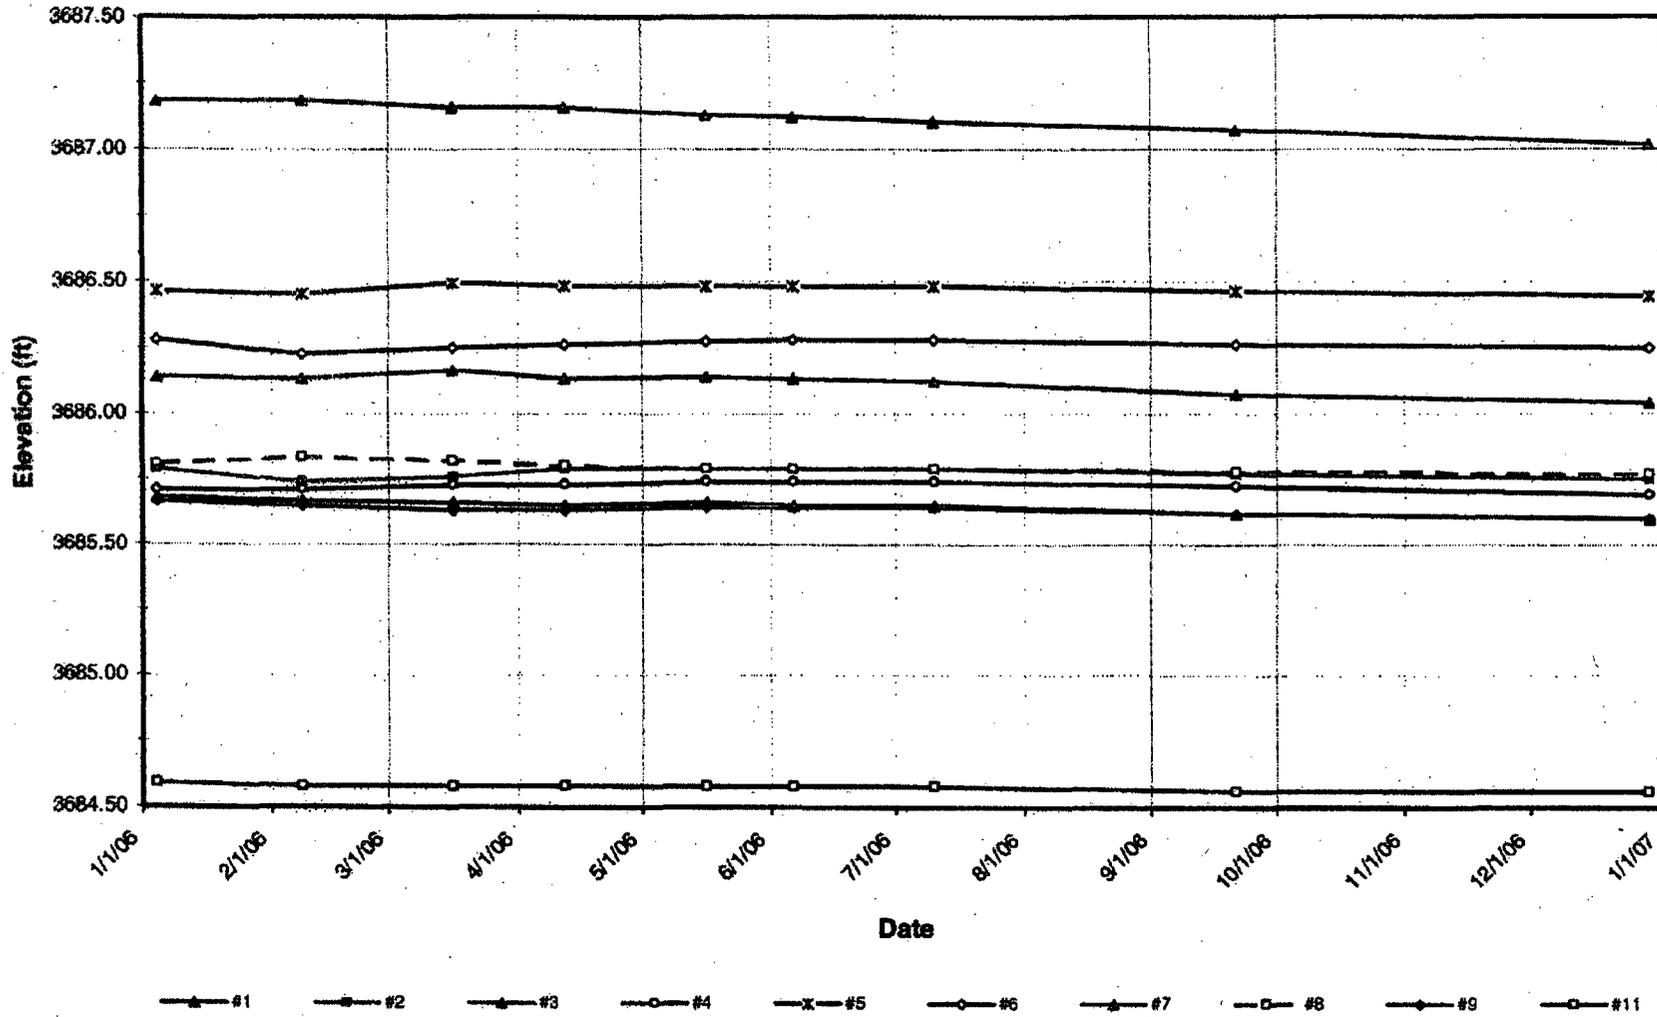
Apex Pond 2 - Settlement Monument Elevations

The elevation at Monument #7 (near the impoundment center) decreased the most (1.9 inches) during 2006. Interestingly, the elevation at monument #11, which is the nearest monument to #7, and is also located near the center, decreased a total of only 0.36 inches over that same time period. Slightly greater settlement in and nearer the center of the impoundment is to be expected as significant quantities of fill were placed in this area during construction.

Based on data collected to date, MEI recommends that Hecla continue with their current plan and collect elevation data quarterly. Please call or email me if you have any questions concerning this review.

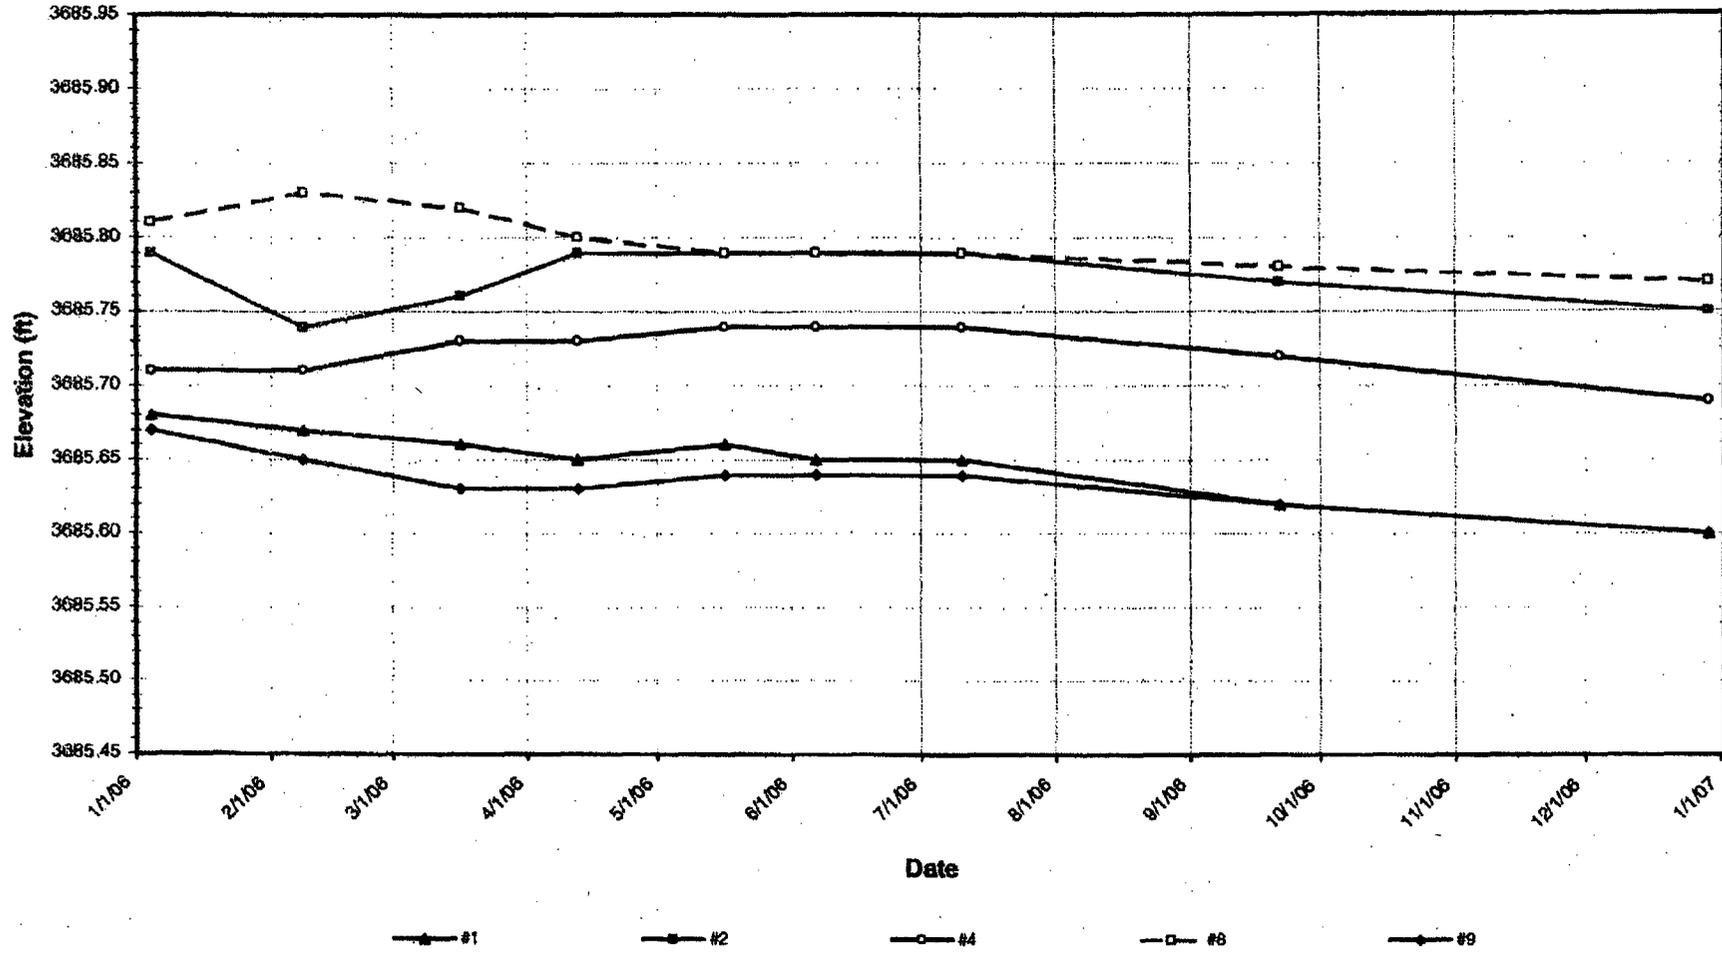
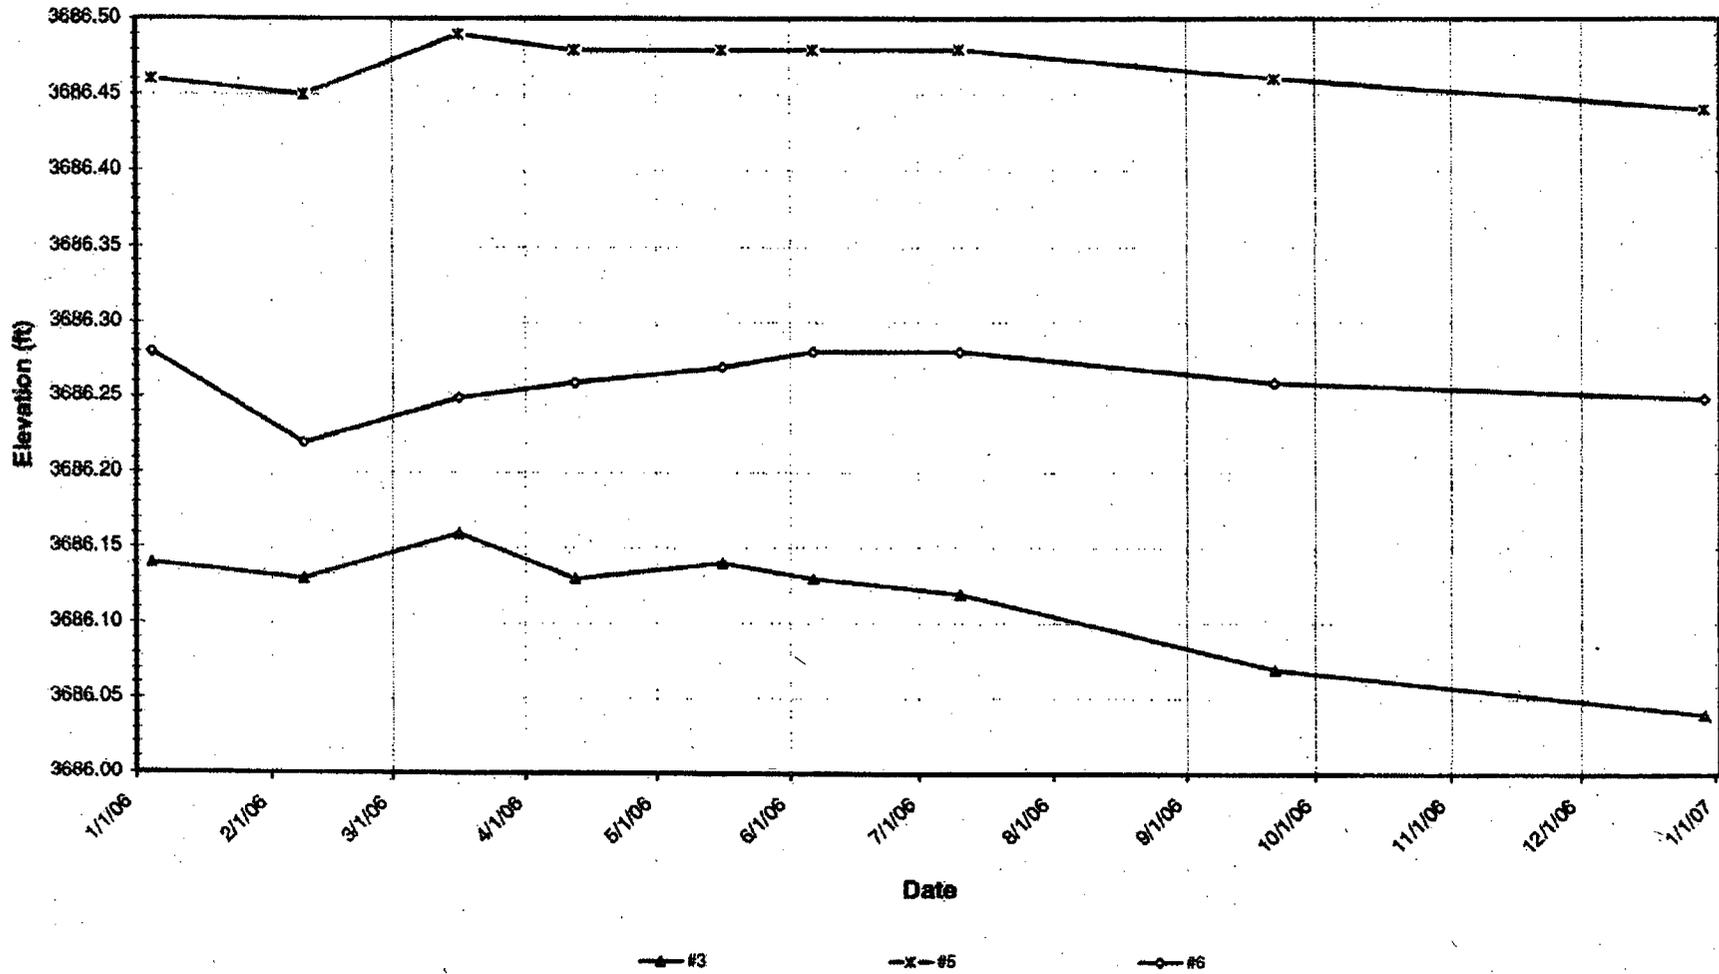
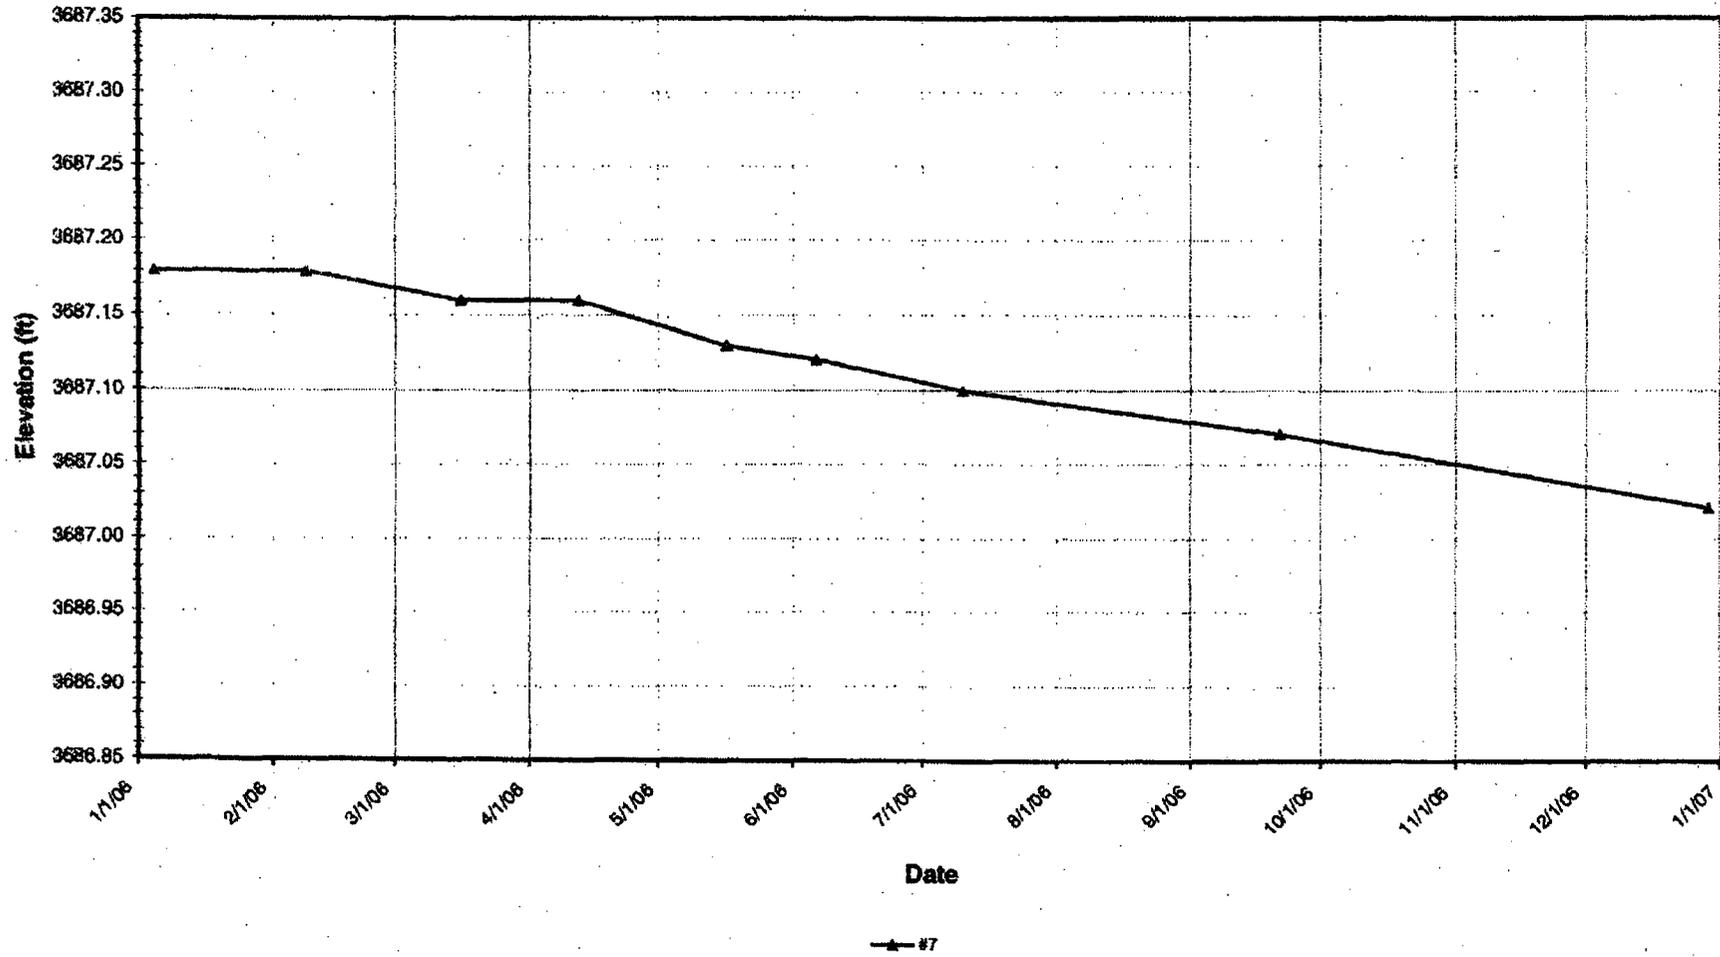
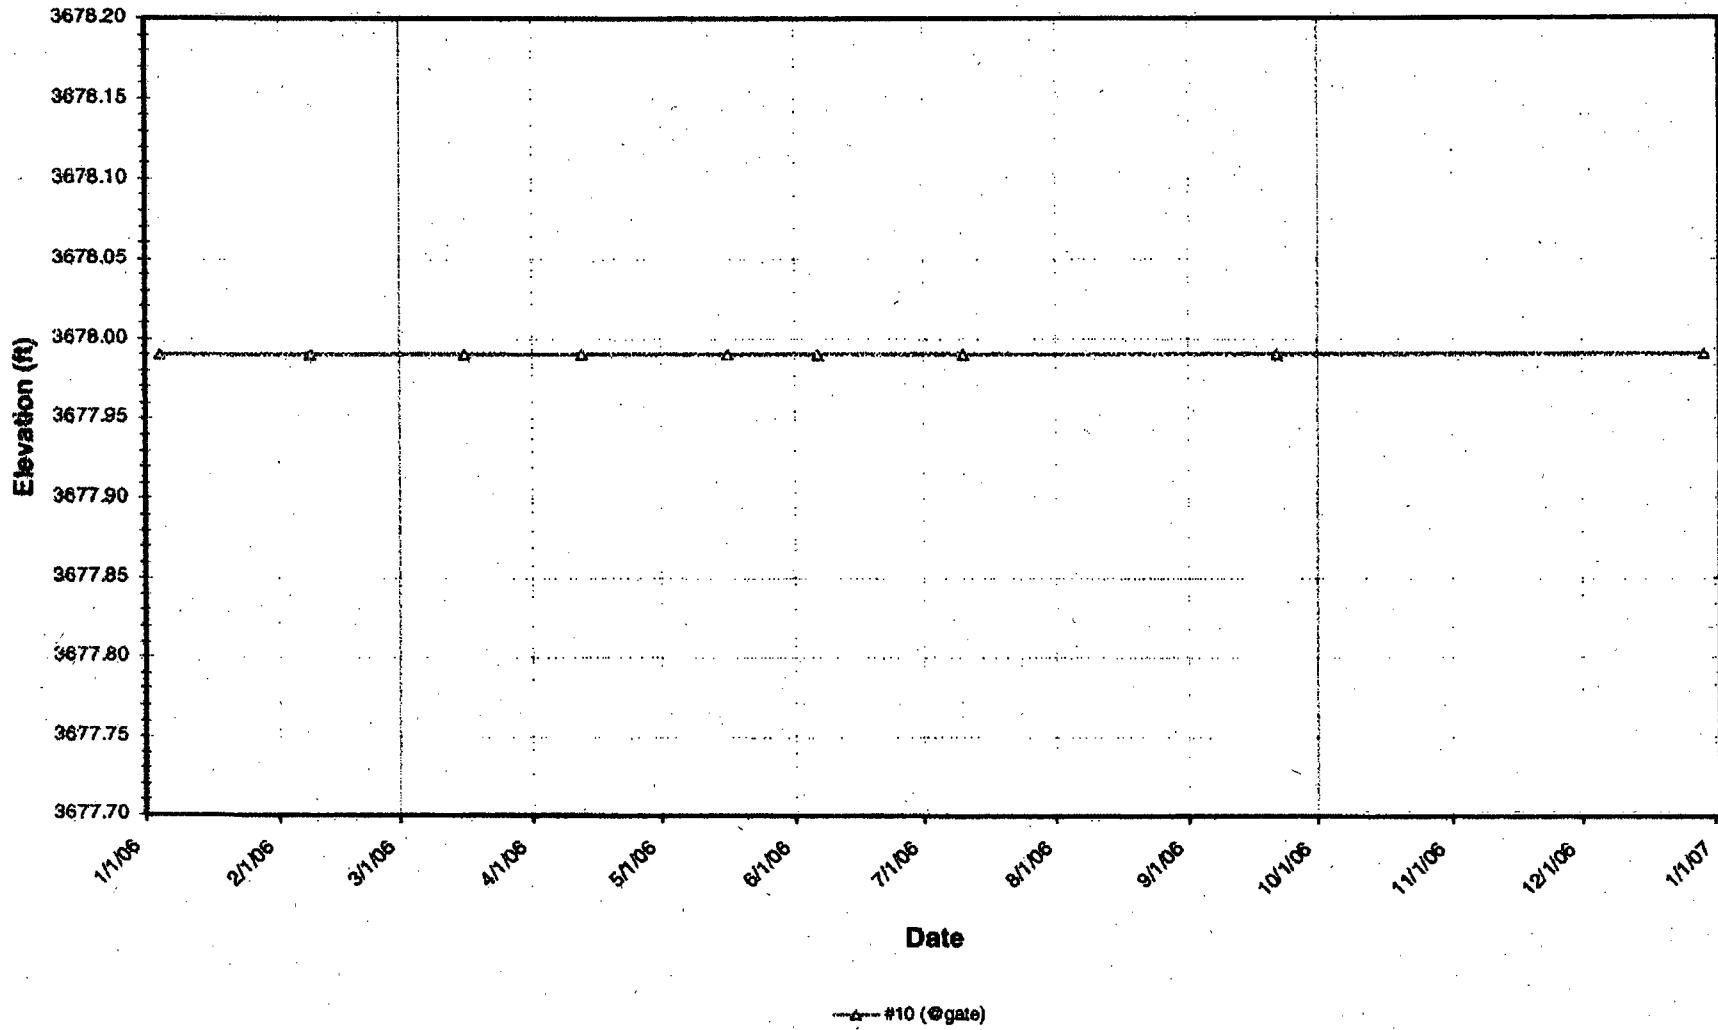
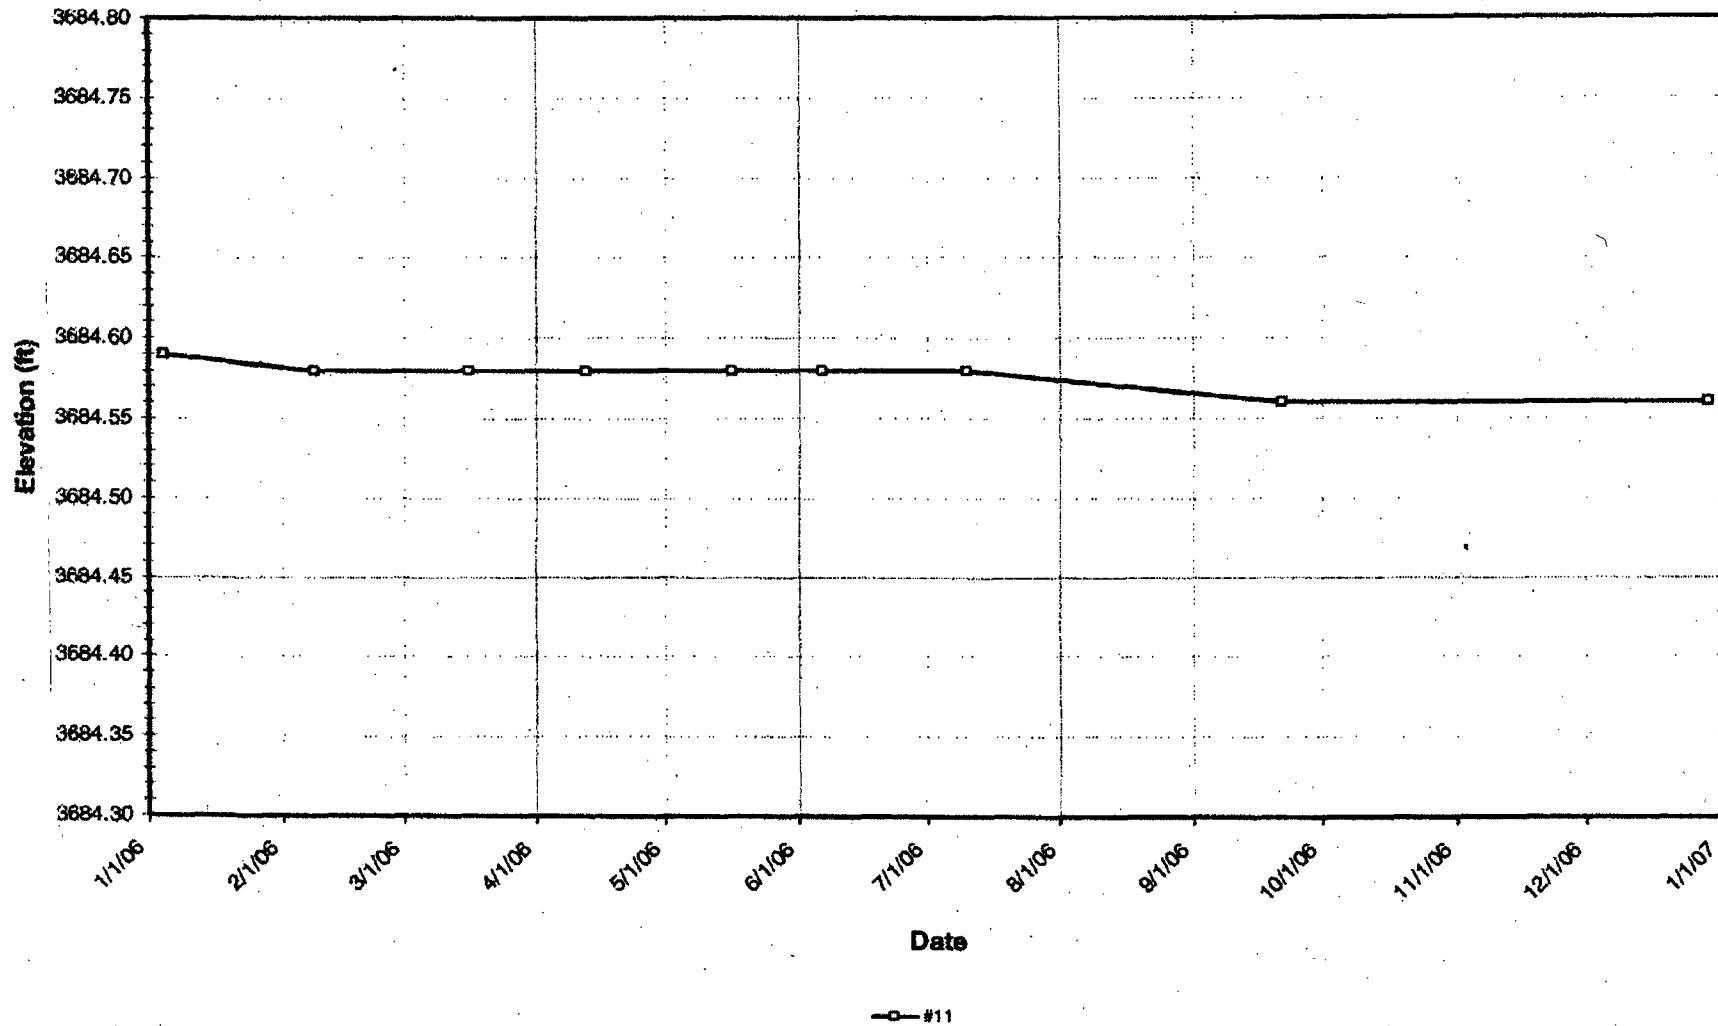
All elevation data provided by Alpha Engineering is presented graphically on the following pages. The first graph shows all monuments (except #10 the baseline point) on a scale that allows all data to be compared. The next five graphs have expanded and equivalent "Y" axes scales in order to more clearly show elevation changes and for ease of comparison between graphs. Based on a review of the graphs it appears that the rate of elevation change for all monuments is consistent. A monument location map (provided by Alpha Engineering) is attached on the last page of this document.
